# Upper River Bandon Aquatic and Riparian Survey 2021

Prepared for Bandon Angling Association By Pascal Sweeney B.Sc., M.Sc., Sweeney Consultancy, Rahan, Mallow, Co. Cork

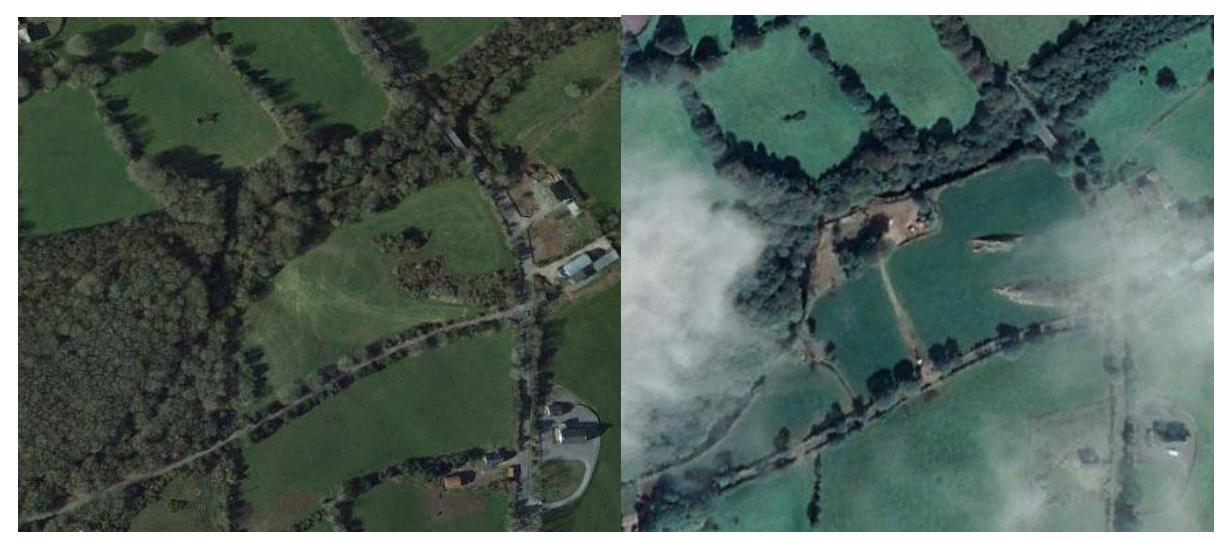
# Figure 13. Satellite images showing woodland cleared upstream of Keenrath BridgeGoogle Earth Pro: 2013Google Earth Pro: 2019

Satellite images (Figure 13) show that woodland along the right (southern) bank of the river, immediately upstream of Keenrath Bridge was cleared some time between 2013 and 2019. Rock armouring is being put in place in an effort to stop the bank erosion resulting from these works (Photo 39). A hardcore yard constructed beside the riverbank (storing equipment and a few silage bales at the time of fieldwork) can also be seen in the 2019 satellite image. There is also some rock armouring of the right bank upstream of the confluence with the Garrown River at ITM 51907 55716 (Photo 37).

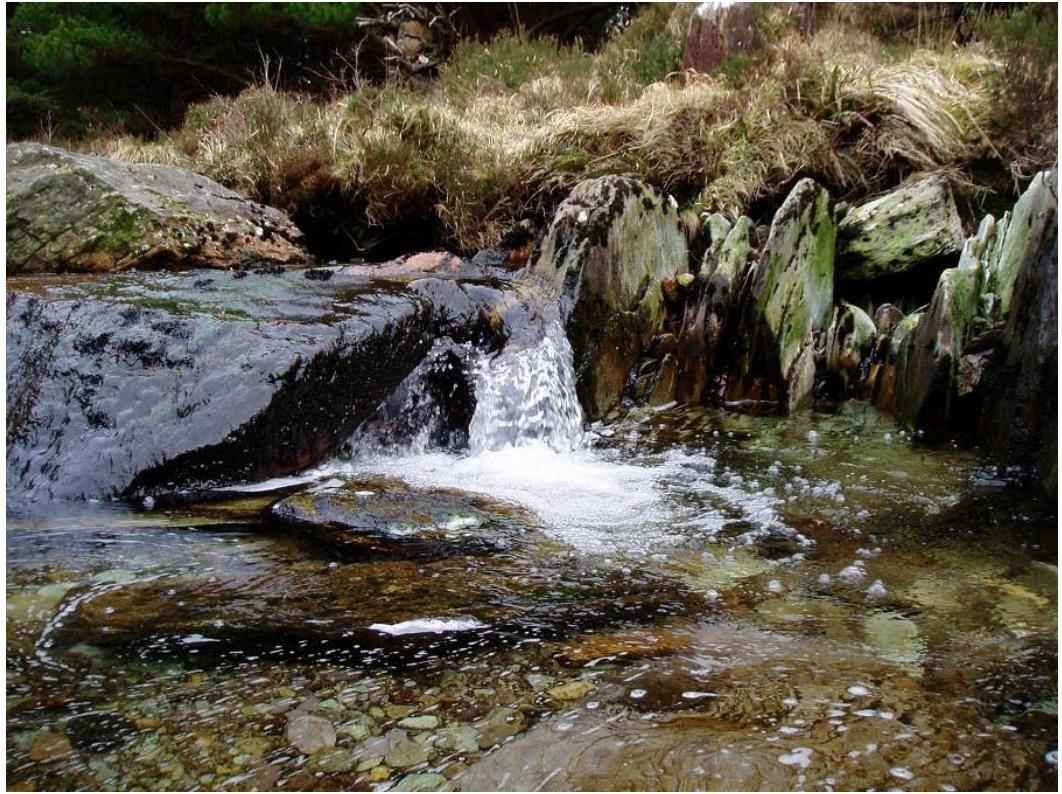
While the small cascades over boulders and outcropping bedrock in the upper part of this branch (Photo 3) would be slight obstacle for upstream migrating fish, the main man-made obstacle is a forestry bridge (Photo 12) at ITM 51643 55610, consisting of four cylindrical culverts and mass concrete. Adult salmon could find this difficult in upstream migration.

Photo 3: Small cascade over bedrock

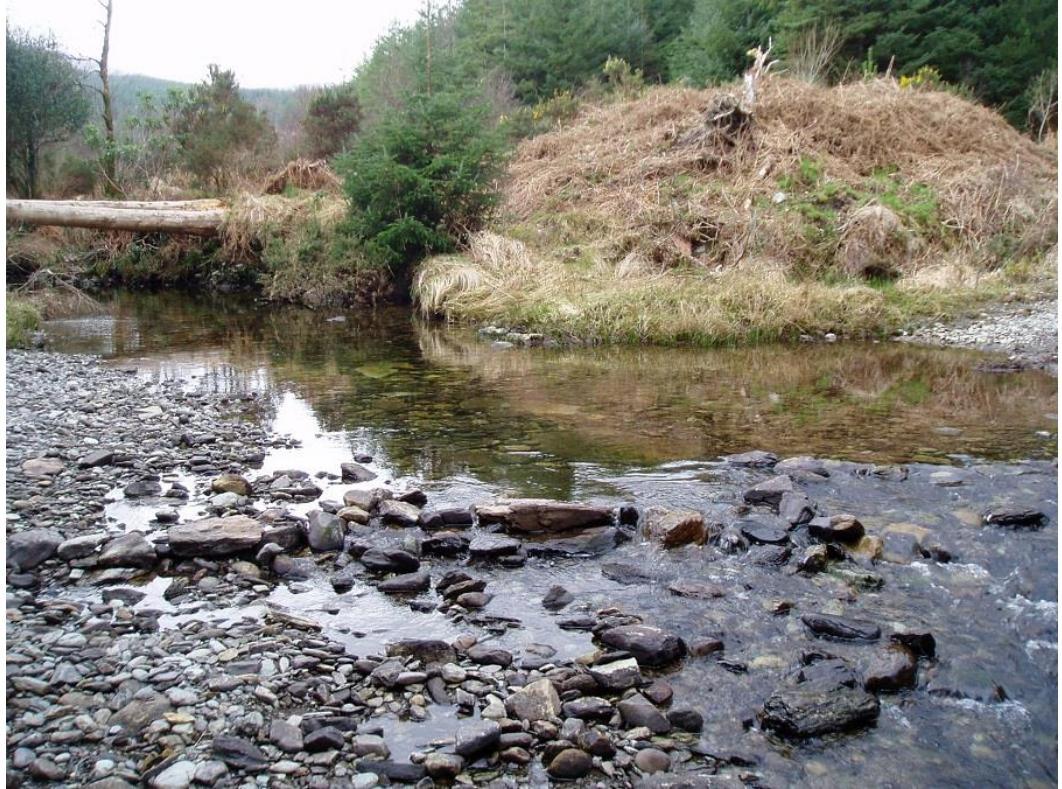
Site N2:
 Q4-5

The slight dip in Q-value at the ford on the forestry road is likely to be attributable to some nutrient release from decomposing brash in the area that was clearfelled in 2020 (Google Earth Pro shows conifers in this block in September 2019). No evidence of machinery working close to the watercourse is evident and brash is kept well back from the stream (Photo 13). However, some leaching of nutrients from the brash is inevitable, as It has been demonstrated that, following clearfelling of conifers, plant nutrients, including phosphates and nitrates, leach from the brash (Titus and Malcolm, 1992; Cummins and Farrell, 2003; Davis, 2005) and in some circumstances this can result in increased export of these nutrients to streams (Likens *et al.,* 1970; Ahtiainen and Huttunen, 1999).

Photo 4: Sampling Site N2, downstream of ford on forestry road

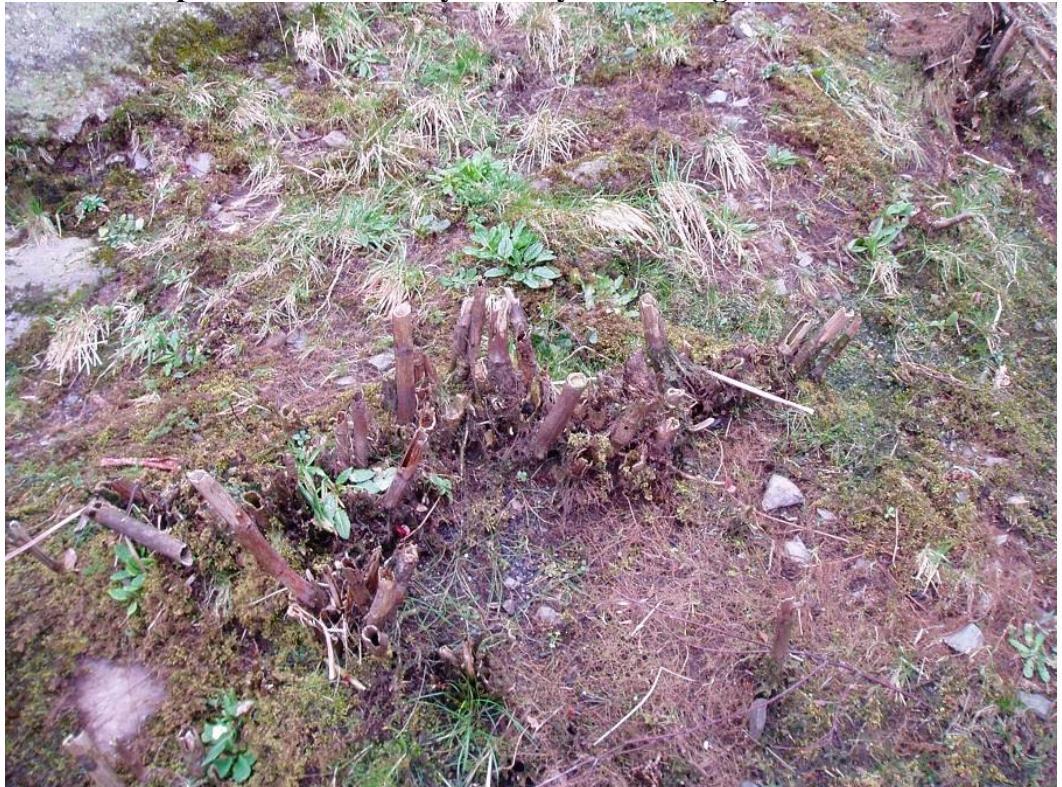
A stand of Japanese knotweed (*Fallopia japonica*) is located beside the bridge on the forestry road at ITM 51643 55610. At the time of fieldwork, new shoots were beginning to emerge (Photo 14).

Photo 14: Japanese Knotweed by forestry road bridge

The patch of Japanese knotweed beside the forestry road bridge on the northern branch should be treated with herbicide until it is eradicated. Otherwise, this plant could spread and quickly get out of control in the upper catchment. Contact with Coillte would be necessary as it is on their property.

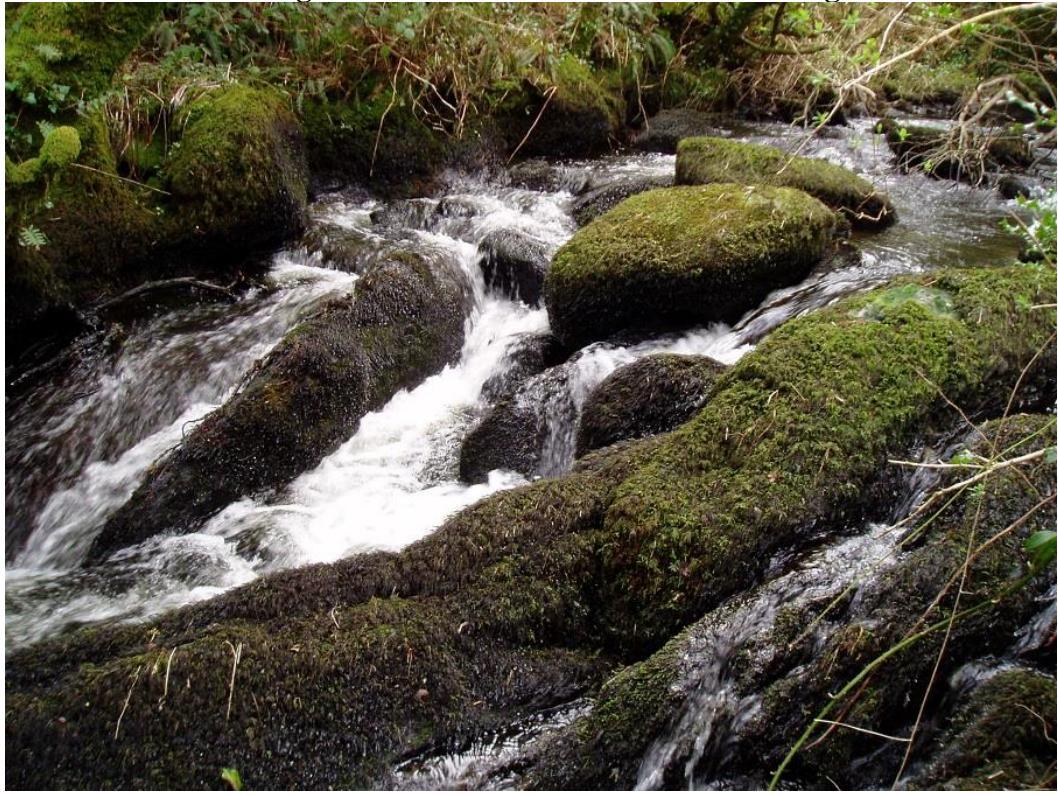
The fast flow and cascades through channels in the bedrock just downstream of Annees Bridge (Photo 17) would be slight obstacle for upstream migrating fish. Also, where the watercourse is divided into two channels fownstream of Farnanes Bridge, a willow is growing across the left channel at ITM 51688 55564 (Photo 26), causing an obstruction that, from evidence of debris, results in overland flow in flood conditions.

Photo 17: Flow through channels in bedrock at Annees Bridge

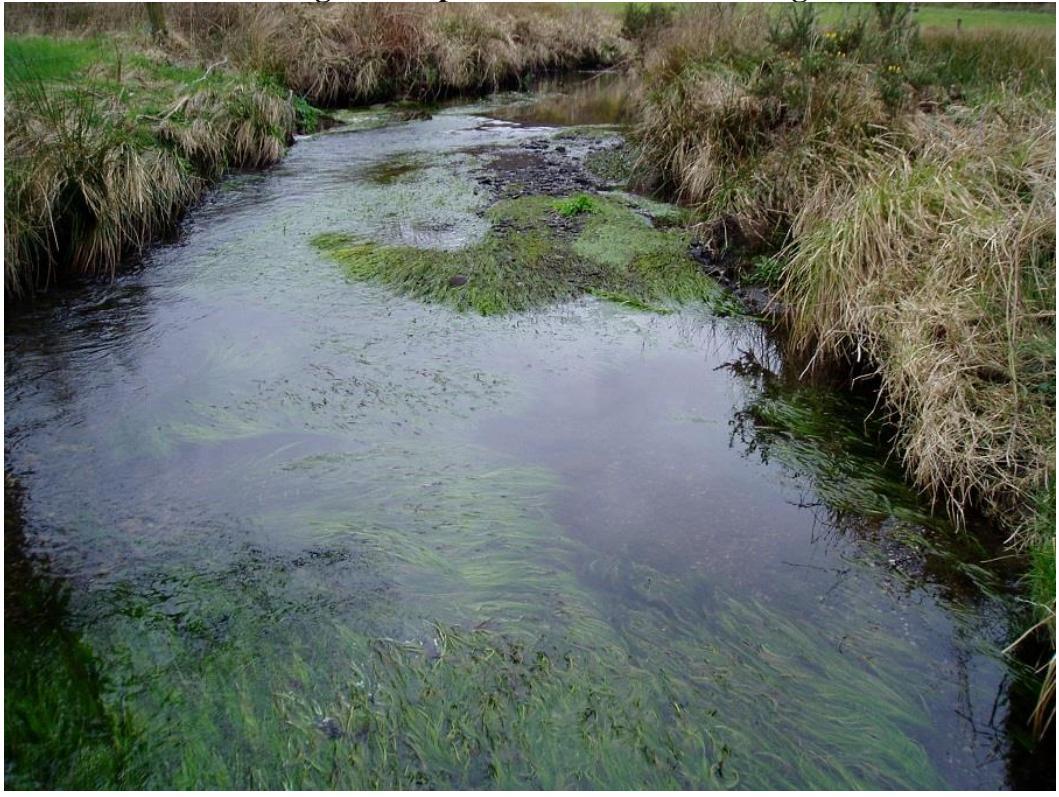
The level of shade at the upstream end of the southern branch is not a serious problem as this part of the shannel is of limited usefulnees for salmonids. Downstream of Annees bridge, this shade continues where more gravels are present. There is also tunnelling downstream of Farnanes Bridge. Lack of shade upstream of Farnanes Bridge is resulting in excessive *Ranunculus* growth.

Photo 21: Ranunculus growth upstream of Farnanes Bridge

Excessive *Ranunculus* growth is a problem at some gravels in unshaded sections. Some planting of trees upstream of Farnanes Bridge is recommended. Young birch trees have already been planted at intervals along the right bank upstream of Keenrath Bridge.

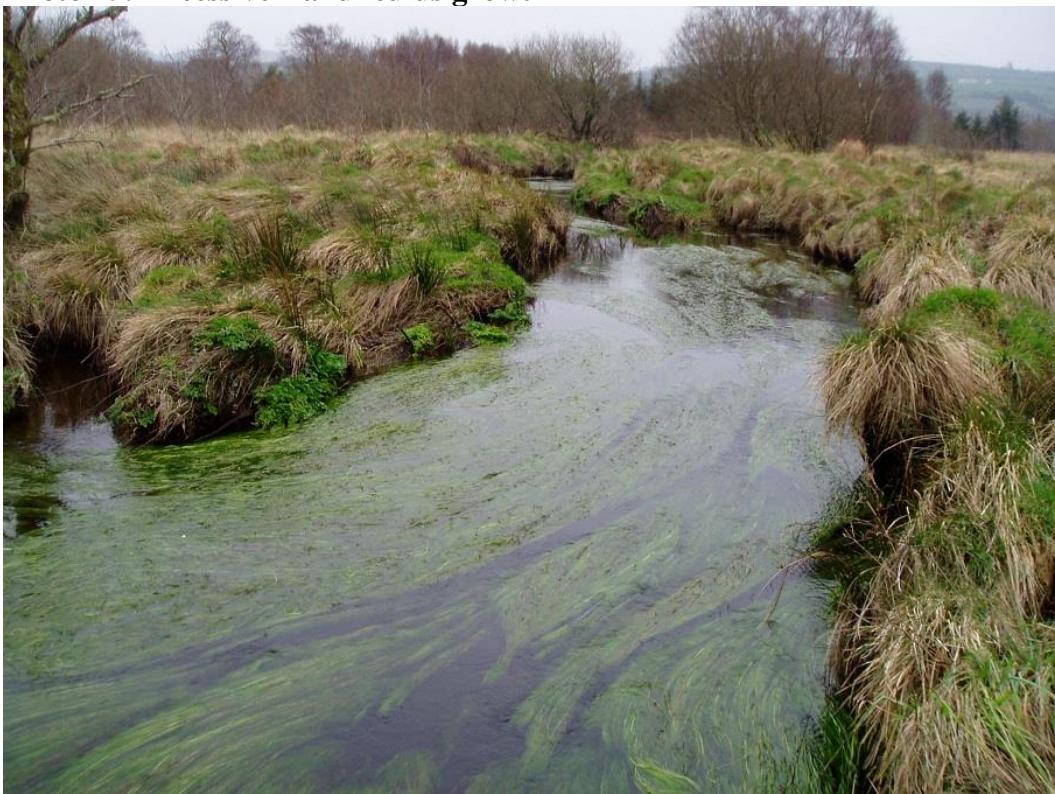
Photo 25: Excessive Ranunculus growth

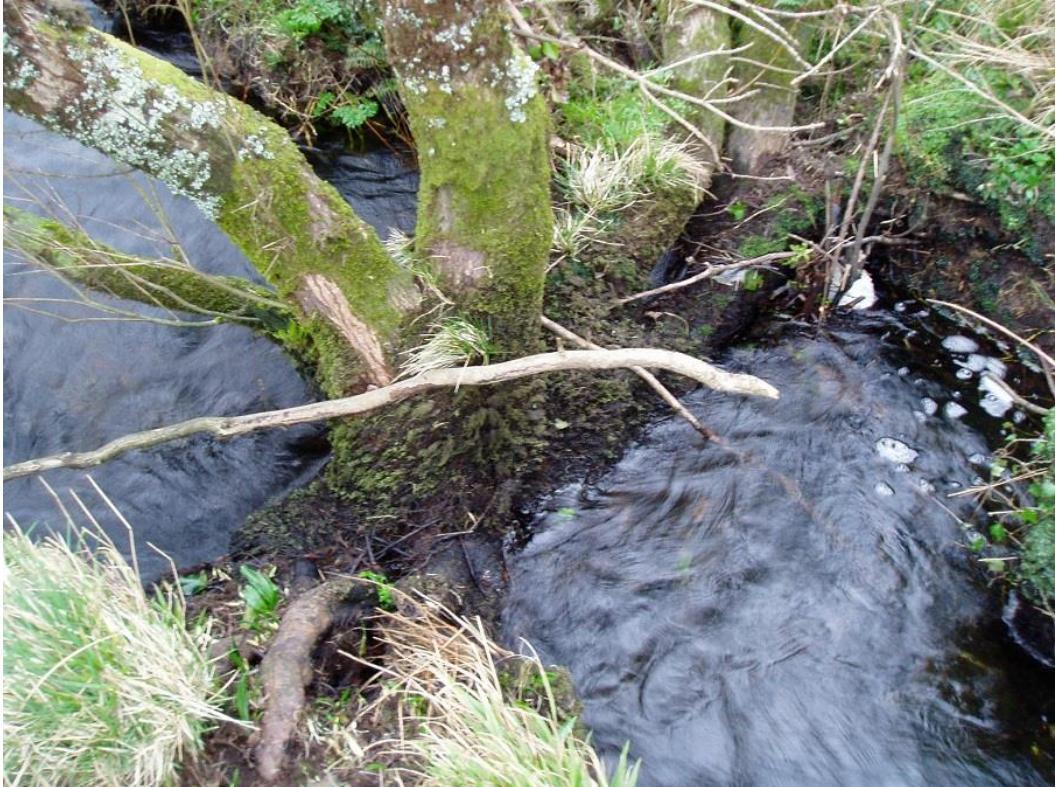
Photo 26: Willow obstructing flow in left channel

As the willow tree that is obstructing the left channel of the southern branch is downstream of the freshwater pearl mussel population here, it could be removed.

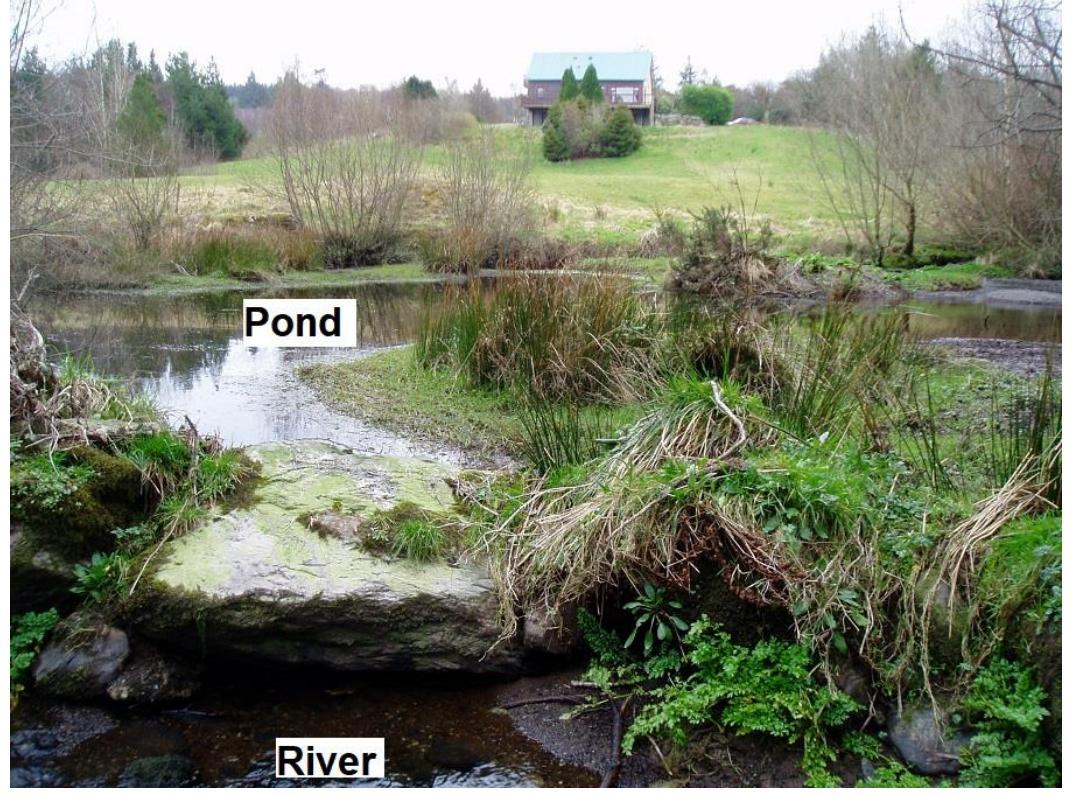
At ITM 51642 55510, a pond has been created (Figure 10), separeted from the river channel by a line of boulders (Photo 27). This pond has evidently infilled somewhat since it was first created.

Photo 27: Pond by river

The pond beside the southern branch is filling in. Contact should be made with the house owners to ensure that they will not dig it out, which could cause a significant silt insult to the adjacent river habitat.

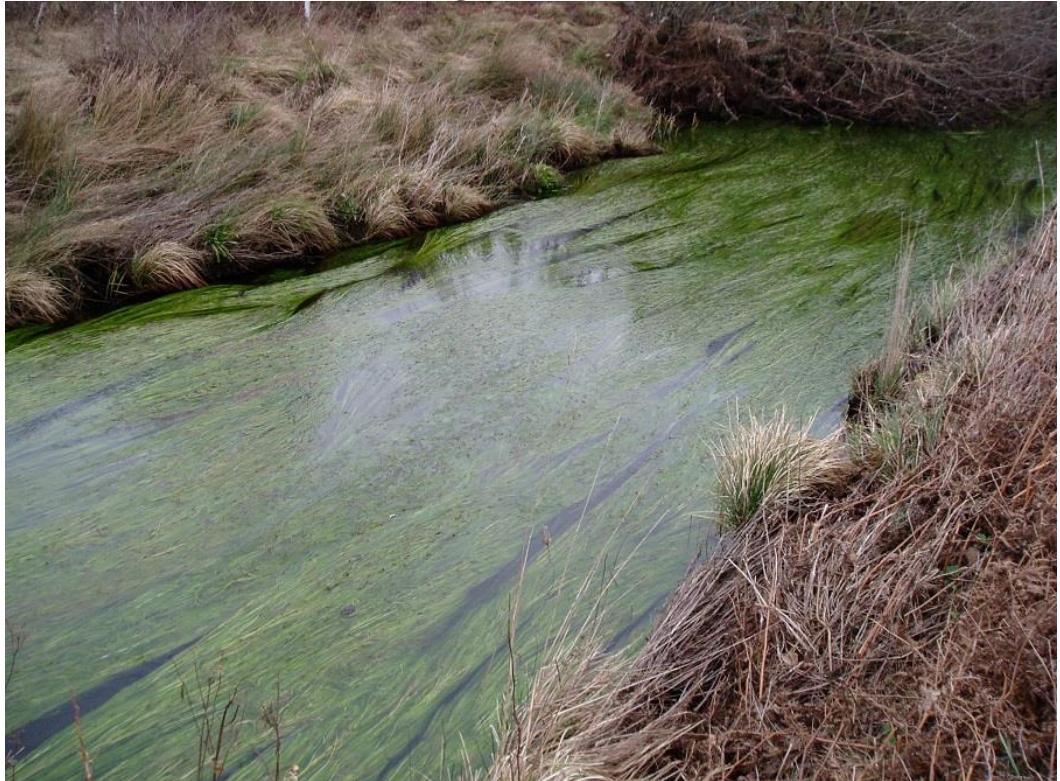
Downstream of Keenrath bridge, where gravels are present, there is tunnelling, which would cause quite dense shade when bankside hazels are in leaf. Lack of shade upstream of Keenrath Bridge is resulting in strong *Ranunculus* growth.

Photo 32: Excessive Ranunculus growth in unshaded area

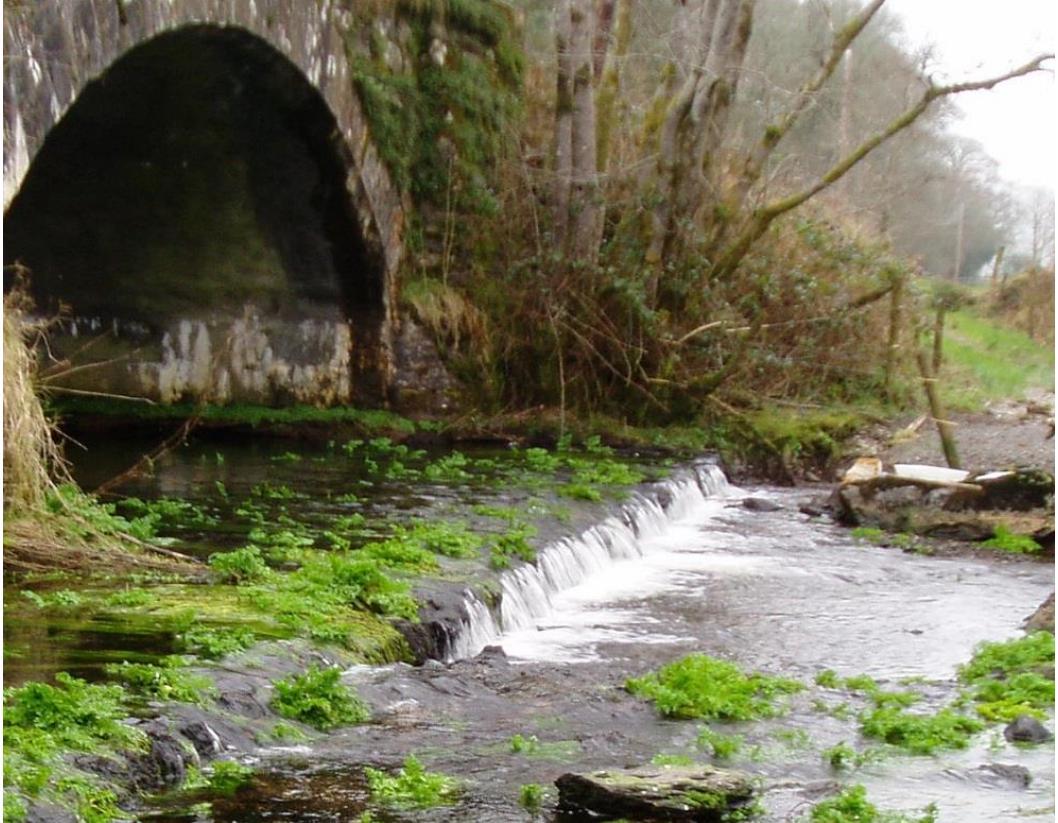
While the cascades over outcropping bedrock (Photo 33) would be slight natural obstacle for upstream migrating fish, the main man-made obstacle is the bridge apron of Keenrath Bridge (Photo 38), where there is a vertical drop of c.40cm on the left side with most flow.

Photo 38: Bridge apron at Keenrath Bridge Sampling Site M1

A small rock ramp at the downstream side of the apron of Keenrath Bridge would facilitate upstream fish migration.

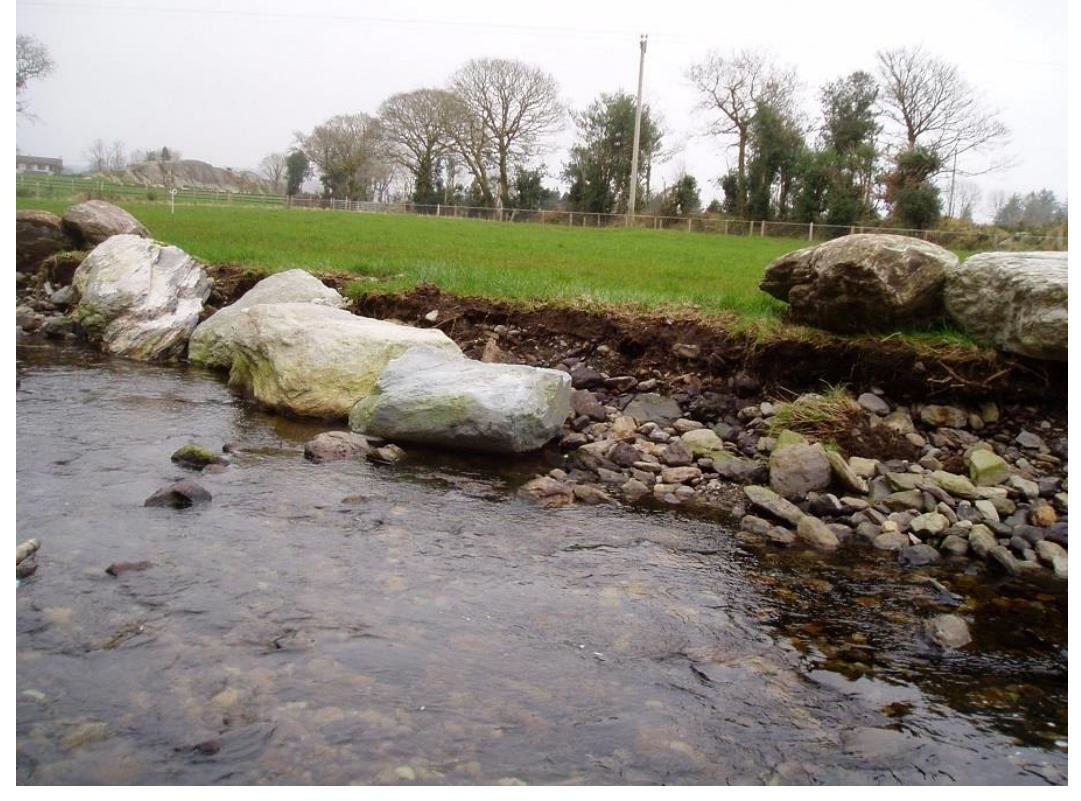
While siltation was not evident in the riverbed at the time of fieldwork, it is clear that some must have resulted from the bank erosion upstream of Keenrath Bridge.

Photo 39: Bank erosion and boulders upstream of Keenrath Bridge

Discussion should be had with the owner of the land upstream of Keenrath Bridge to ensure that bank protection works are properly carried out.

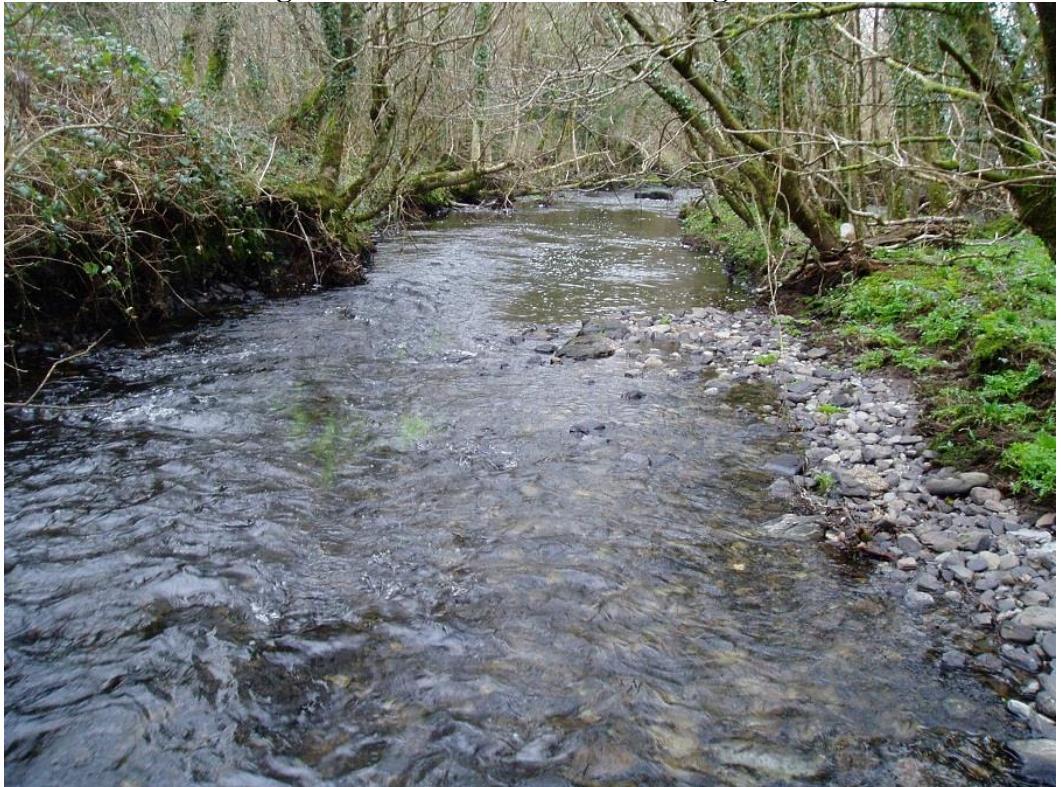
Photo 40: Tunnelling downstream of Keenrath Bridge

Some coppicing of the trees causing excessive shading of the gravel section downstream of Keenrath Bridge might be possible. However, as this stretch is not far upstream of the Bandon River SAC, an Appropriate Assessment report would be needed and the National Parks and Wildlife Service would probably require a survey of freshwater pearl mussels.

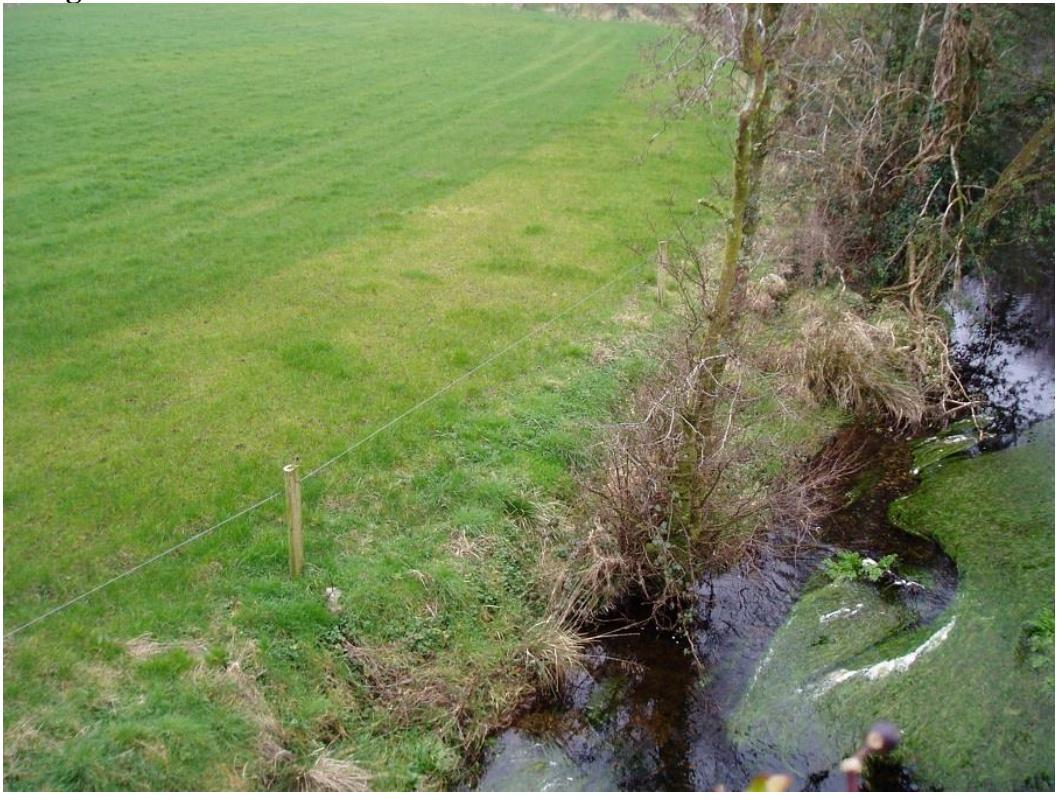
Land improvement and fertilisation to the riverbank upstream of Keenrath Bridge (Photo 41) is an obvious source of nutrient input to this section of river.

Photo 41: Improved agricultural grassland to bank upstream of Keenrath Bridge

Farmers should be contacted to make sure slurry and fertiliser spreading is kept back from riverbanks.

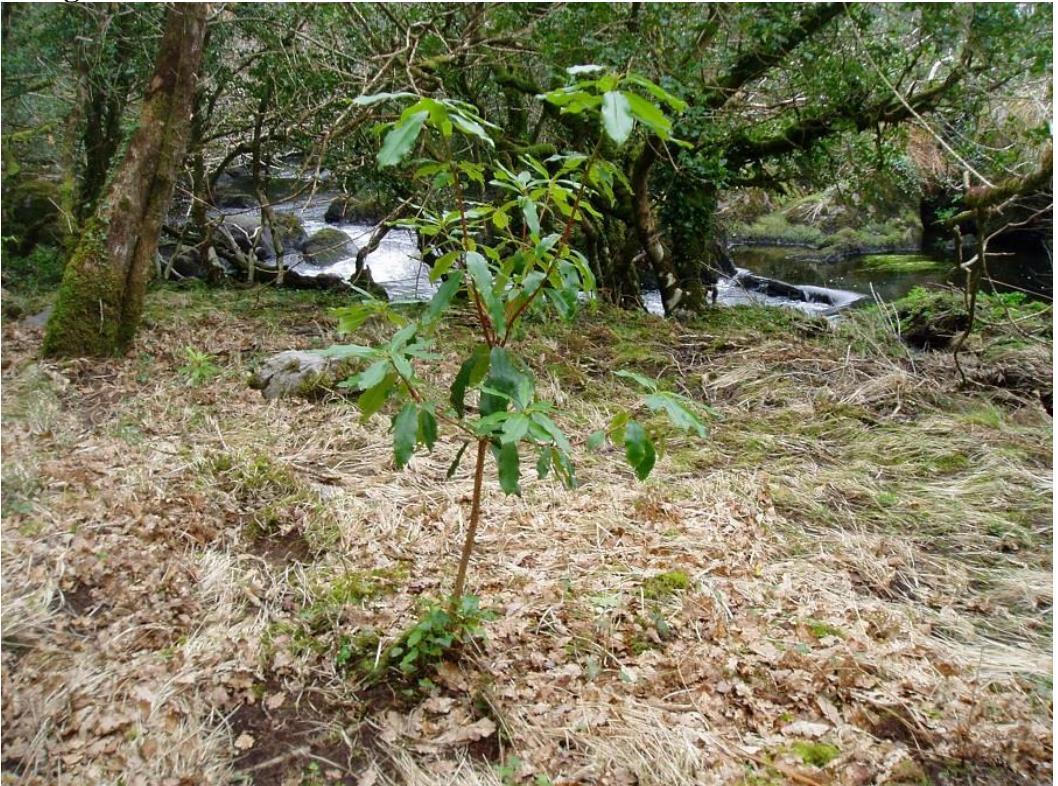
Small individual plants of rhododendron (*Rhododendron ponticum*) are scattered along open parts of the terrestrial habitat towards the upper end of this section of river channel in peat habitats. However, it is thought that they are unlikely to become so prolific here to cause problems. In the woodland upstream of Keenrath Bridge, there are a few of these plants (Photo 42) where there is potential for them to take over the habitat and lower riparian biodiversity.

Photo 42: *Rhododendron ponticum* in oak woodland upstream of Keenrath Bridge

As rhododendron could take over the shrub layer in the oak woodland on the left bank upstream of Keenrath Bridge, a plan for its control is advisable.
