# Upper River Bandon Aquatic and Riparian Survey 2021

Prepared for Bandon Angling Association By Pascal Sweeney B.Sc., M.Sc., Sweeney Consultancy, Rahan, Mallow, Co. Cork

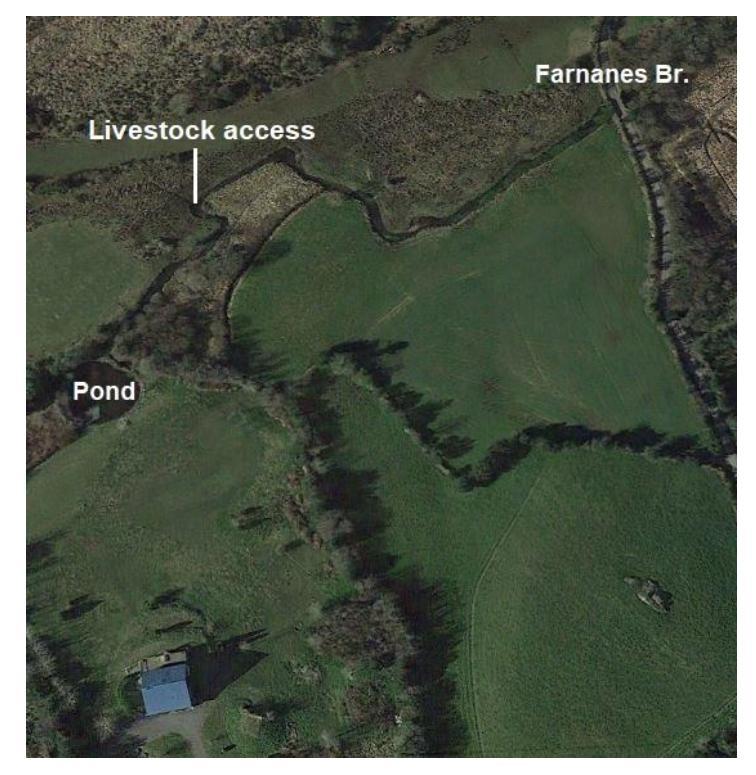
Figure 10. Pond and Livestock Access

At ITM 51642 55510, a pond has been created (Figure 10), separeted from the river channel by a line of boulders (Photo 27). This pond has evidently infilled somewhat since it was first created.

The pond beside the southern branch is filling in. Contact should be made with the house owners to ensure that they will not dig it out, which could cause a significant silt insult to the adjacent river habitat.

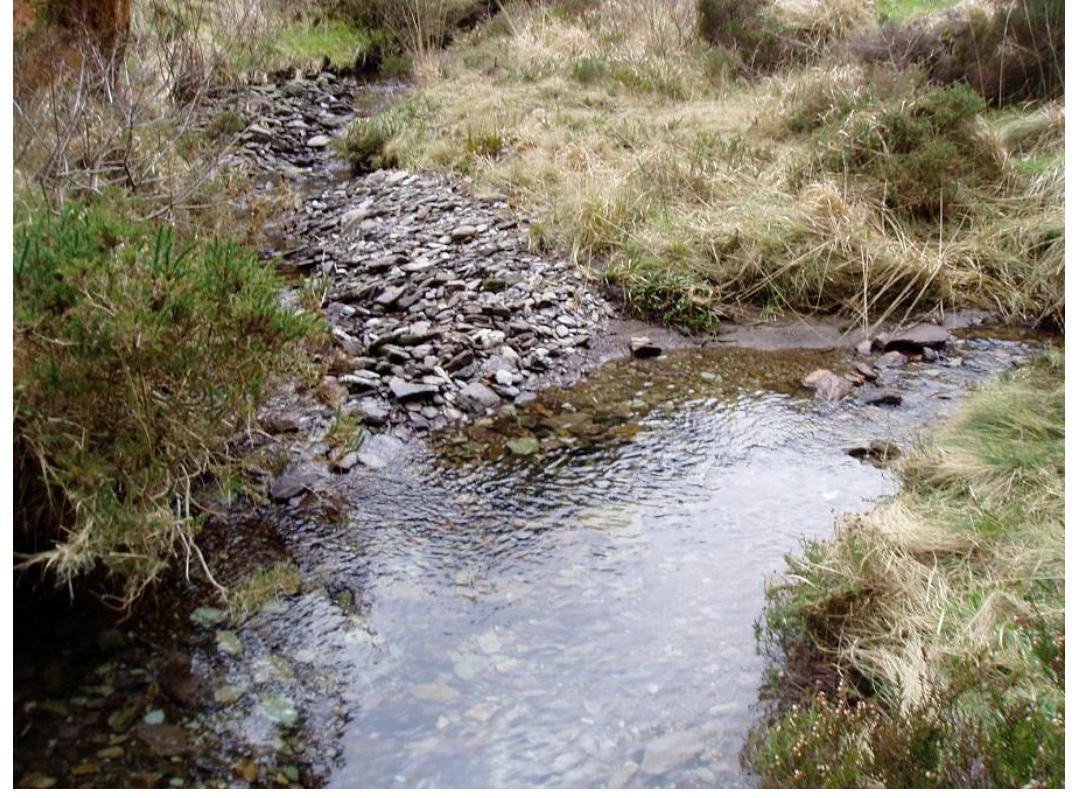
# Photo 1: Northern Branch. Confluence of two headwater streams

At the confluence of headwaters at ITM 51328 55565, the nothern branch (Figure 5), flowing east, was small and shallow at the time of fieldwork (Photo 1), but the channel indicates large variations in flow (Photo 2). The substratum here is mostly flat gravels, but with occasional small cascades over boulders and outcropping bedrock (Photo 3). Downstream of a ford on the forestry road at ITM 51503 55608 (Photo 4), riffle over gravels is the dominant flow type (Photo 5). In the section downstream of the abrupt turn to the south at ITM 51652 55652, there is a mix of glide (Photo 6) and riffle (Photo 7) over gravels (Photo 8), with some faster flow over and between boulders and outcropping rock (Photo 9), before slowing down (Photo 10) as the watercourse passes through flatter terrain towards the confluence with the southern branch.

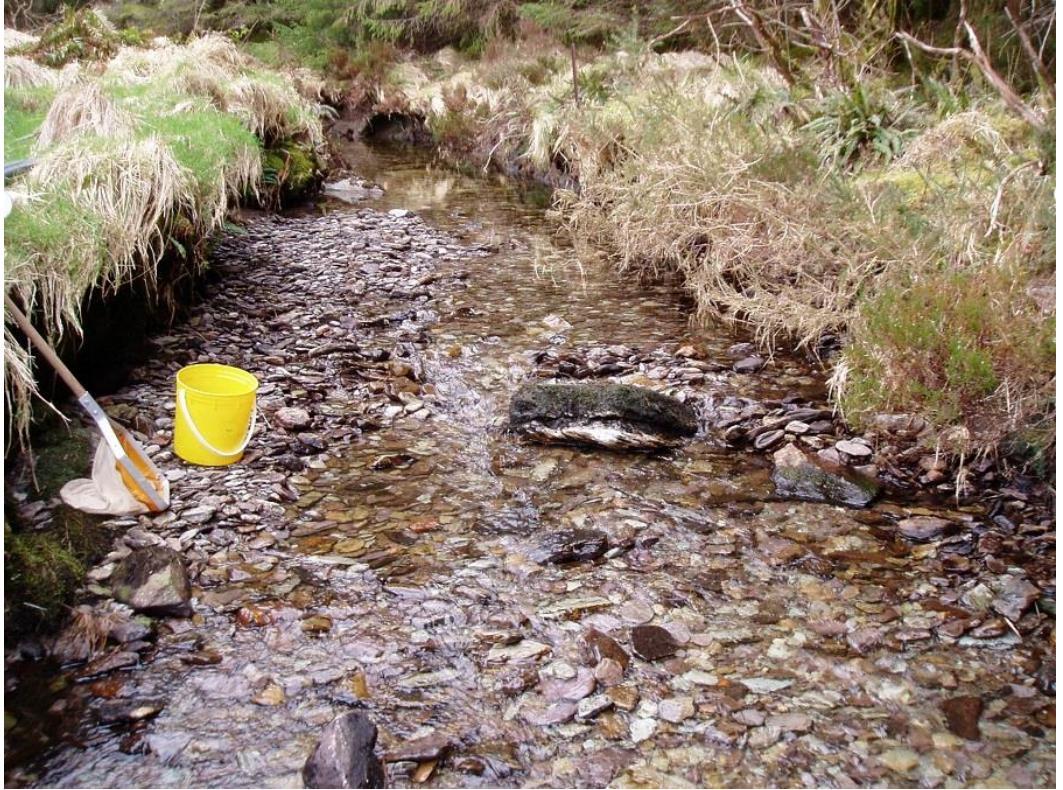
Photo 2: Sampling Site N1

Watercourse	Bandon Northern Branch
Site Code	N1
Grid Reference (ING)	51329 55565
Photograph	2
Sampling depth (m)	0.02
Flow Type	Riffle 100%
Velocity	Fast
Substratum	Gravel
In order of occurrence	Cobble

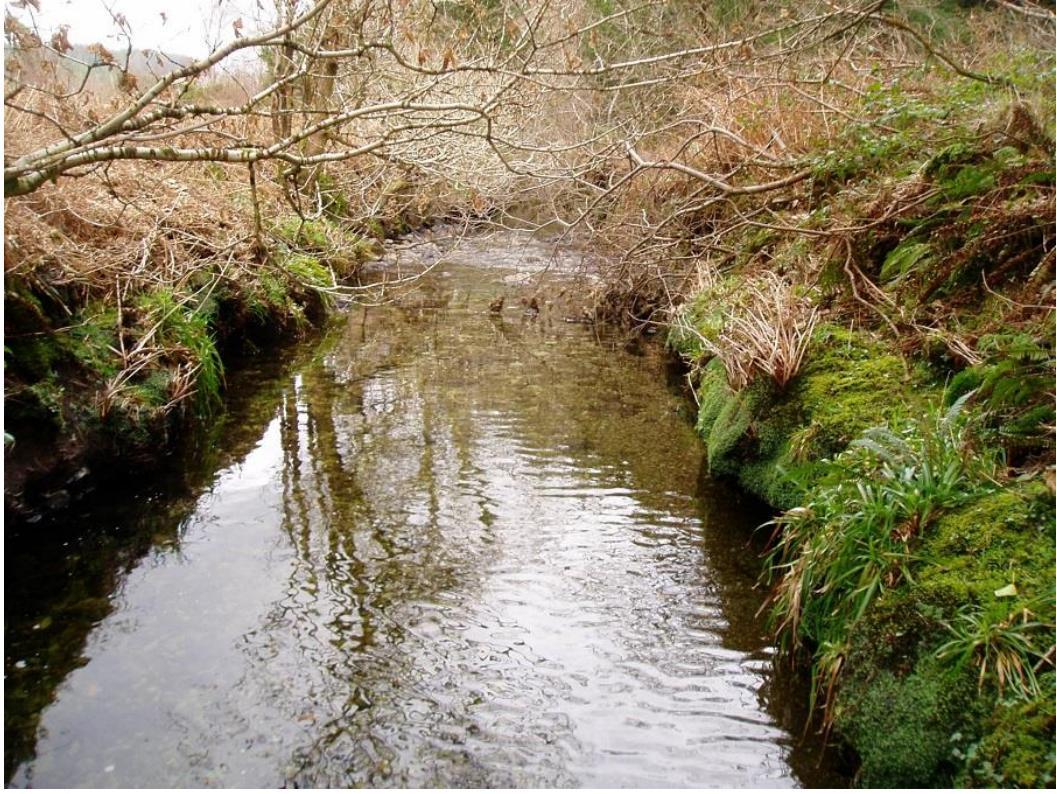
Photo 5: Downstream of ford

From downstream of the ford, deeper gravels are slightly silted, presumably from forestry activity and erosion of peat. There are forestry drains running though mature conifer plantations, but at present, these do not appear to be contributing significantly to silt imputs to the watercourse.

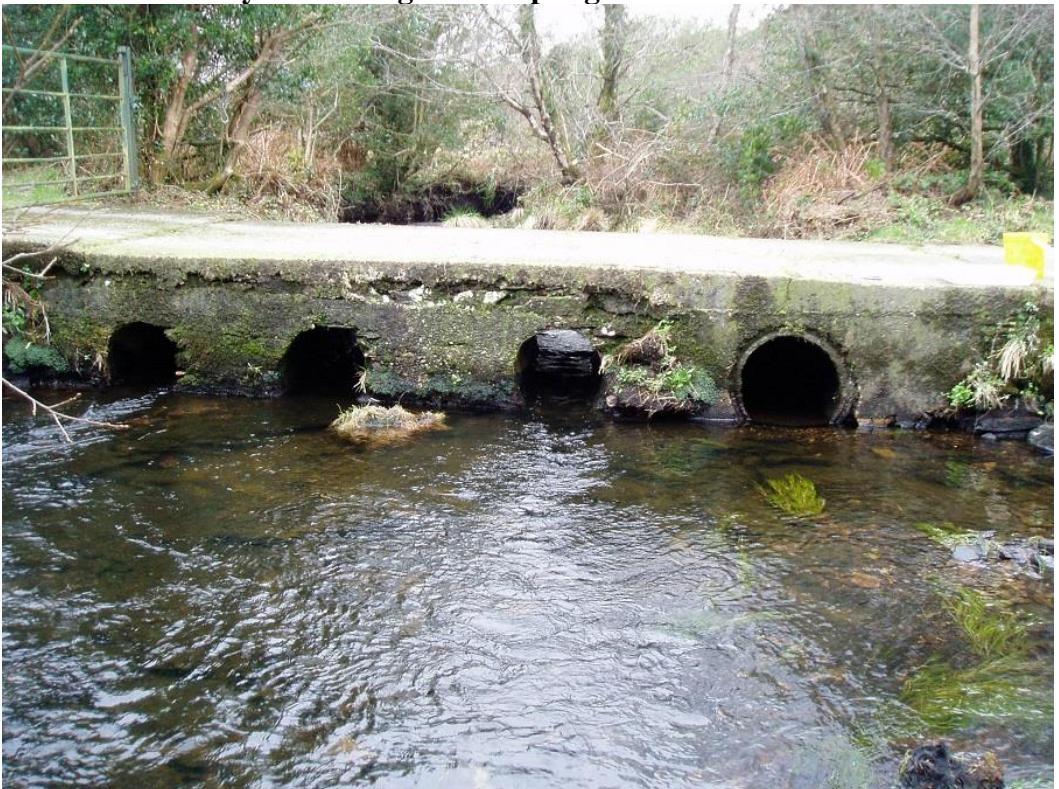
Photo 12: Forestry road bridge at Sampling Site N3

While the small cascades over boulders and outcropping bedrock in the upper part of this branch (Photo 3) would be slight obstacle for upstream migrating fish, the main man-made obstacle is a forestry bridge (Photo 12) at ITM 51643 55610, consisting of four cylindrical culverts and mass concrete. Adult salmon could find this difficult in upstream migration.

Watercourse	Bandon Northern Branch
Site Code	N3
Grid Reference (ING)	51643 55610
Photograph	12
Sampling depth (m)	0.2
Flow Type	Riffle 100%
Velocity	Fast
Substratum	Cobble
In order of occurrence	Gravel
	Peat Silt

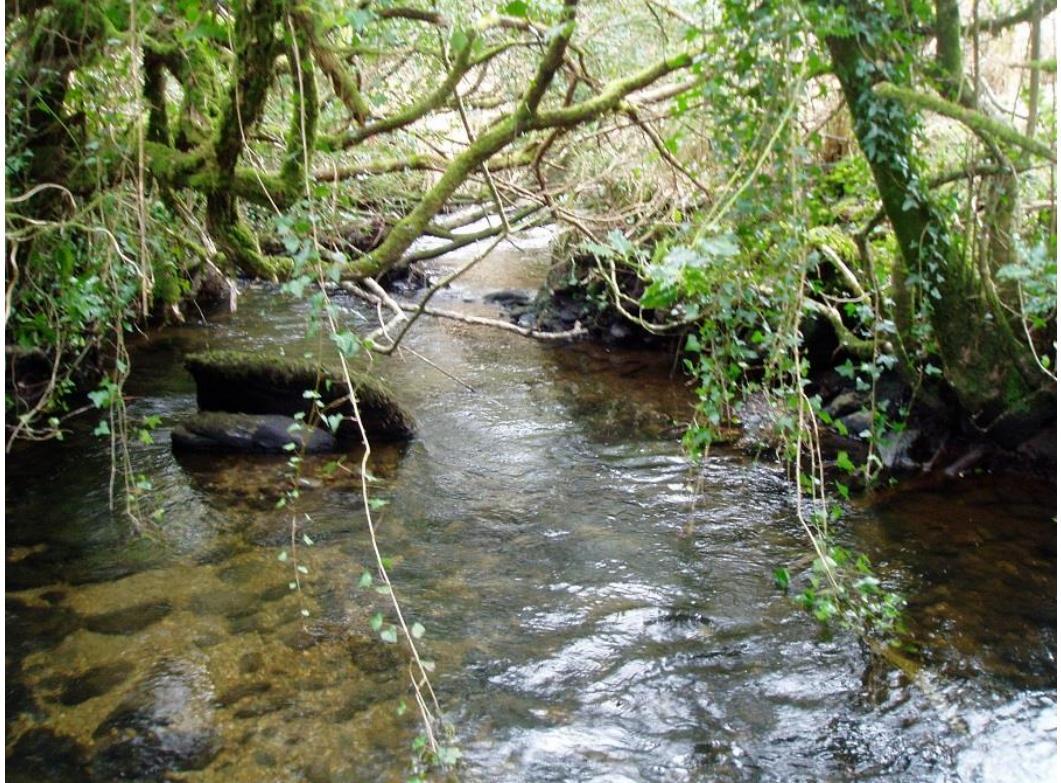
Photo 16: Southern Branch upstream of Annees Bridge. Sampling Site S1

From the outflow of Lough Cullenagh at ITM 51557 55368 flows north to Annees Bridge at ITM 51576 55446 (Figure 7) in a mostly steep sided glen (Photo 15). Flow here is fast, over outcropping rock, boulder, cobble and gravel (Photo 16). Immediately downstream of Annees Bridge, there is a short section of very fast flow and cascade through channels in bedrock (Photo 17). After this, the gradient lessens slightly and, while flow is still fast, it is more riffle and less cascade (Photo 18) down to ITM 51640 55510 (Photo 19). From a short distance downstream of this point to Farnanes Bridge (ITM 51662 55524) the channel is very open, with fast glide and riffle over a mainly gravel substratum (Photo 20). Lack of shade has resulted in strong growth of water crowfoot (*Ranunculus sp.*) in places (Photo 21). Farnanes Bridge is due for repair and is currently supported by scaffolding poles (Photo 22), some of which have collapsed. For circa 470m downstream of Farnanes Bridge to ITM 51693 55559, there is riffle and fast glide (Photo 23). At this point, the channel splits into two smaller channels and the flow slows (Photo 24). These re-join at ITM 51685 55570, from where there is glide over gravel and peat, with dense instream growth of *Ranunculus* (Photo 25) down to the conflence with the northern branch.

Watercourse	Bandon Southern Branch
Site Code	S1
Grid Reference (ING)	51576 55446
Photograph	16
Sampling depth (m)	0.1
Flow Type	Riffle 100%
Velocity	Fast
Substratum	Cobble
In order of occurrence	Gravel
	Boulder

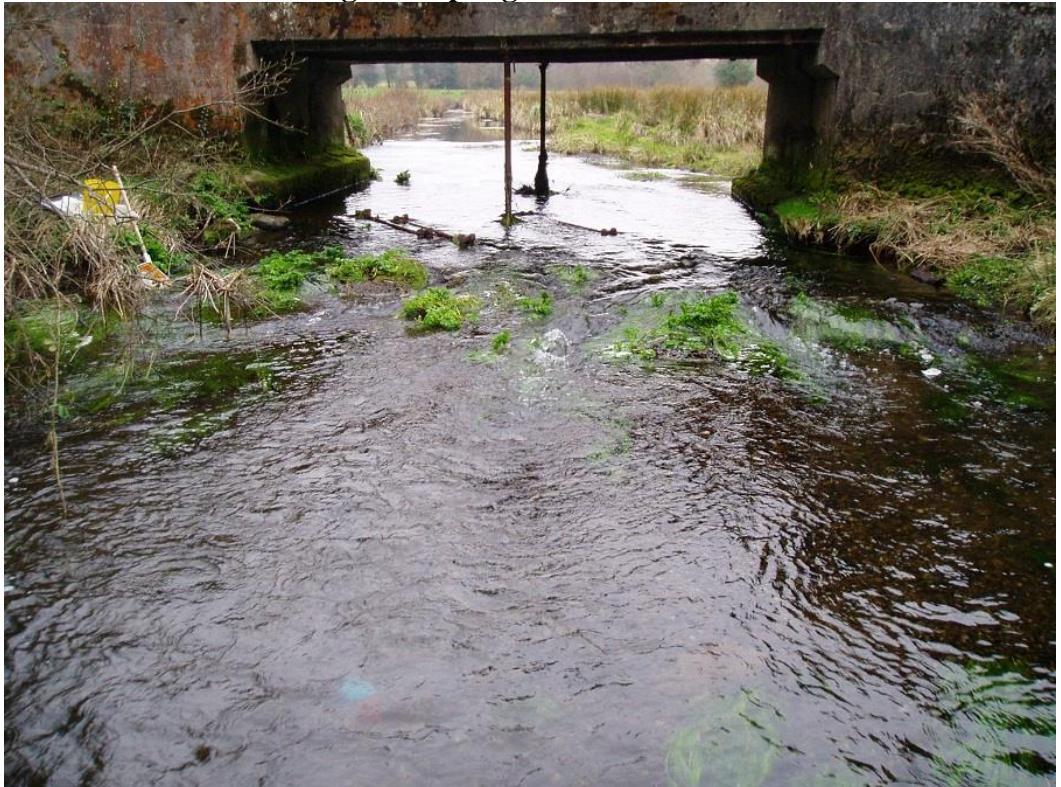
Photo 22: Farnanes Bridge. Sampling Site S2

It is known that repair works are planned for Farnanes Bridge, which is currently supported by scaffolding poles. Cork County Council should be contacted regarding the nature of these works and the need for an Ecological Clerk of Works to be on-site throughout the period when they are being carried out.

Watercourse	Bandon Southern Branch
Site Code	S2
Grid Reference (ING)	51662 55524
Photograph	22
Sampling depth (m)	0.1
Flow Type	Riffle 100%
Velocity	Fast
Substratum	Gravel
In order of occurrence	Cobble

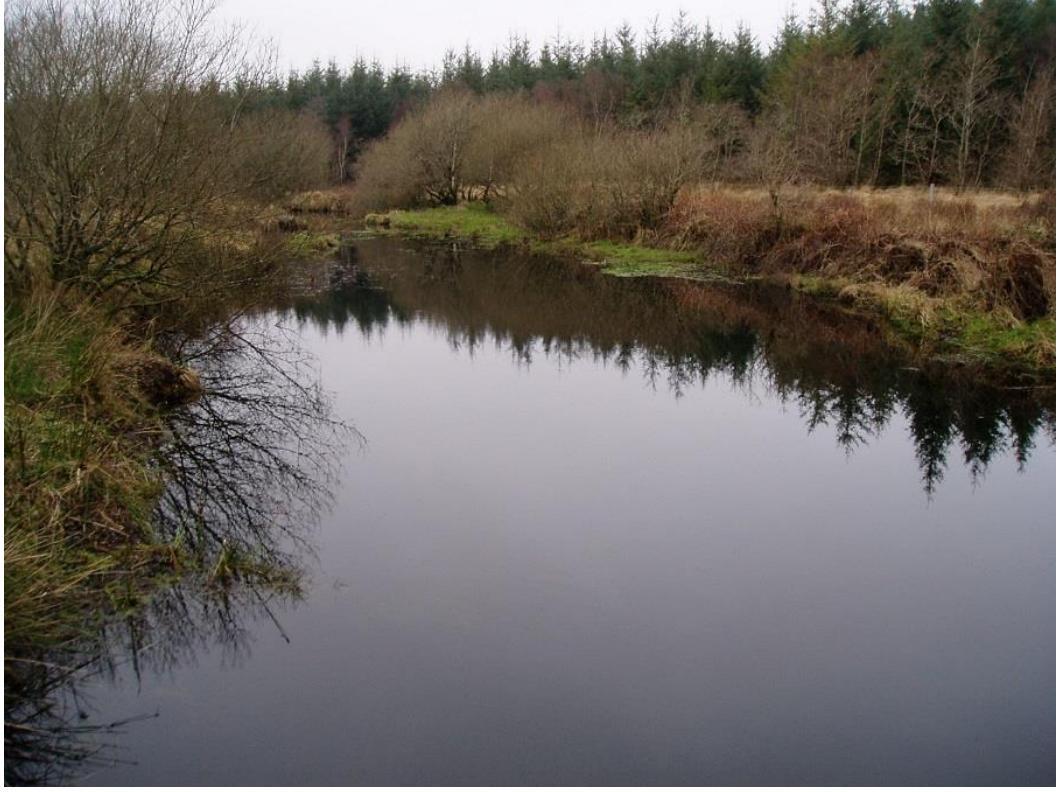
Photo 32: Excessive Ranunculus growth in unshaded area

Downstream of Keenrath bridge, where gravels are present, there is tunnelling, which would cause quite dense shade when bankside hazels are in leaf. Lack of shade upstream of Keenrath Bridge is resulting in strong *Ranunculus* growth.

Excessive *Ranunculus* growth is a problem at some gravels in unshaded sections. Some planting of trees upstream of Farnanes Bridge is recommended. Young birch trees have already been planted at intervals along the right bank upstream of Keenrath Bridge.

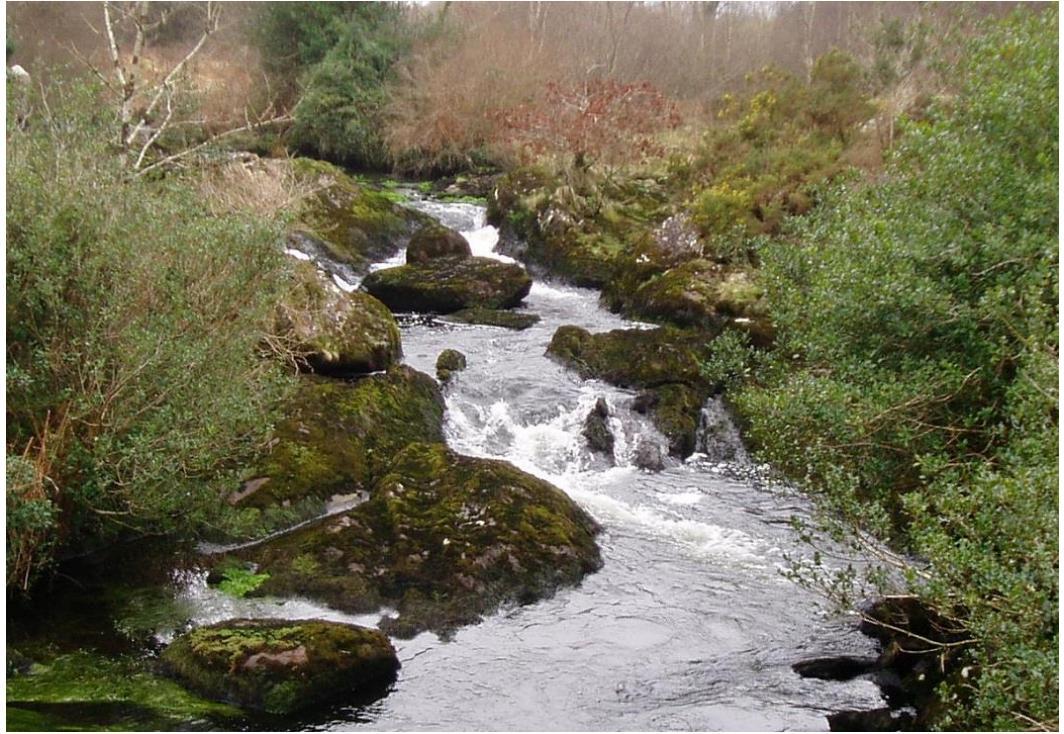
Photo 33: Cascades over bedrock

While the cascades over outcropping bedrock (Photo 33) would be slight natural obstacle for upstream migrating fish, the main man-made obstacle is the bridge apron of Keenrath Bridge (Photo 38), where there is a vertical drop of c.40cm on the left side with most flow.

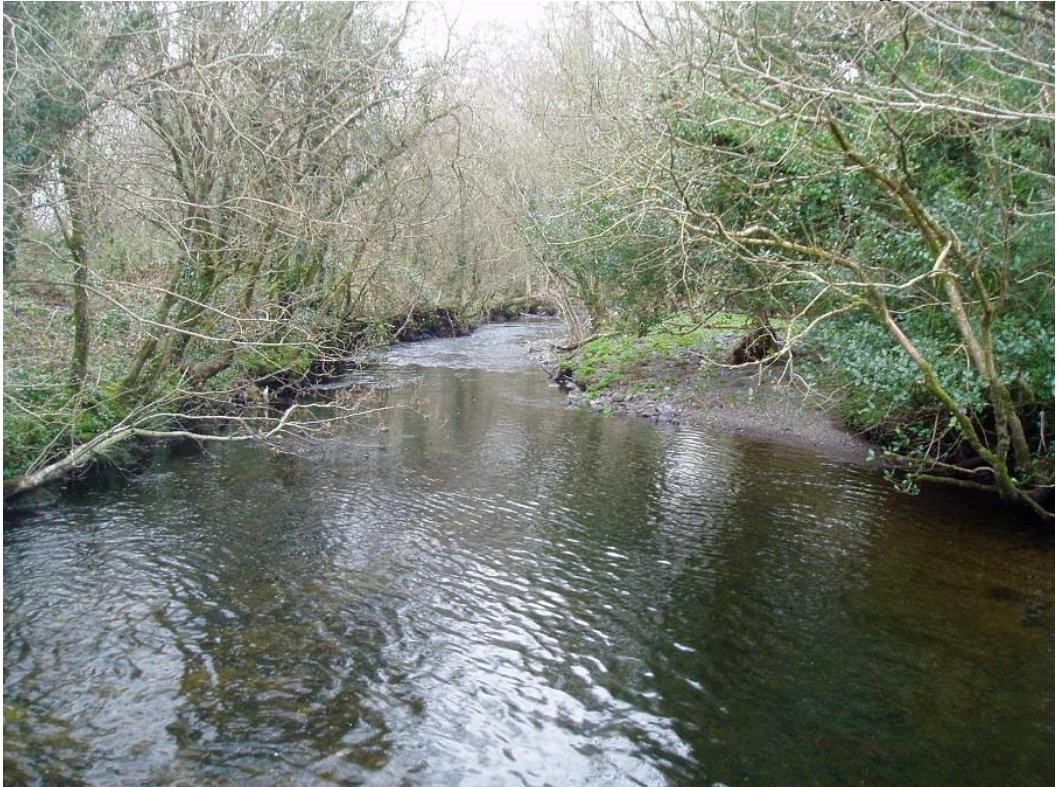
From the confluence of the northern and southern branches at ITM 51682 55593 (Figure 11) to ITM 51694 55603, the glide habitat from the southern branch continues. *Ranunculus* growth is strong here in the unshaded channel (Photo 29). There is then a short section of fast flow, with cascade and riffle over bedrock, boulders and cobble (Photo 30). Then, for approximately 1km, there is glide (Photo 31), with strong *Ranunculus* growth in shallow areas (Photo 32). Flow speed increases from where the water cascades over bedrock at ITM 51823 55643 (Photo 33). This fast flow continues over boulder, cobble and some gravel for the next approximately 900m to ITM 51845 55649 (Photo 34). As the gradient decreases, the flow-type down to Keenrath Bridge is a mixture of riffle and glide (Photo 35). For a few metres immediately downstream of Keenrath Bridge the flow is between and through boulders, after which there is a pool, followed by riffle in a hazel-lined channel (Photo 36). Towards the lower end of the section of river surveyed, to the confluence with the Garrown River at ITM 51907 55716, the channel widens and gets shallower, with gravel dominating the bed (Photo 37).

Satellite images (Figure 13) show that woodland along the right (southern) bank of the river, immediately upstream of Keenrath Bridge was cleared some time between 2013 and 2019. Rock armouring is being put in place in an effort to stop the bank erosion resulting from these works (Photo 39). A hardcore yard constructed beside the riverbank (storing equipment and a few silage bales at the time of fieldwork) can also be seen in the 2019 satellite image. There is also some rock armouring of the right bank upstream of the confluence with the Garrown River at ITM 51907 55716 (Photo 37).

Photo 37: Shallow riffle over gravel at downstream end of survey section

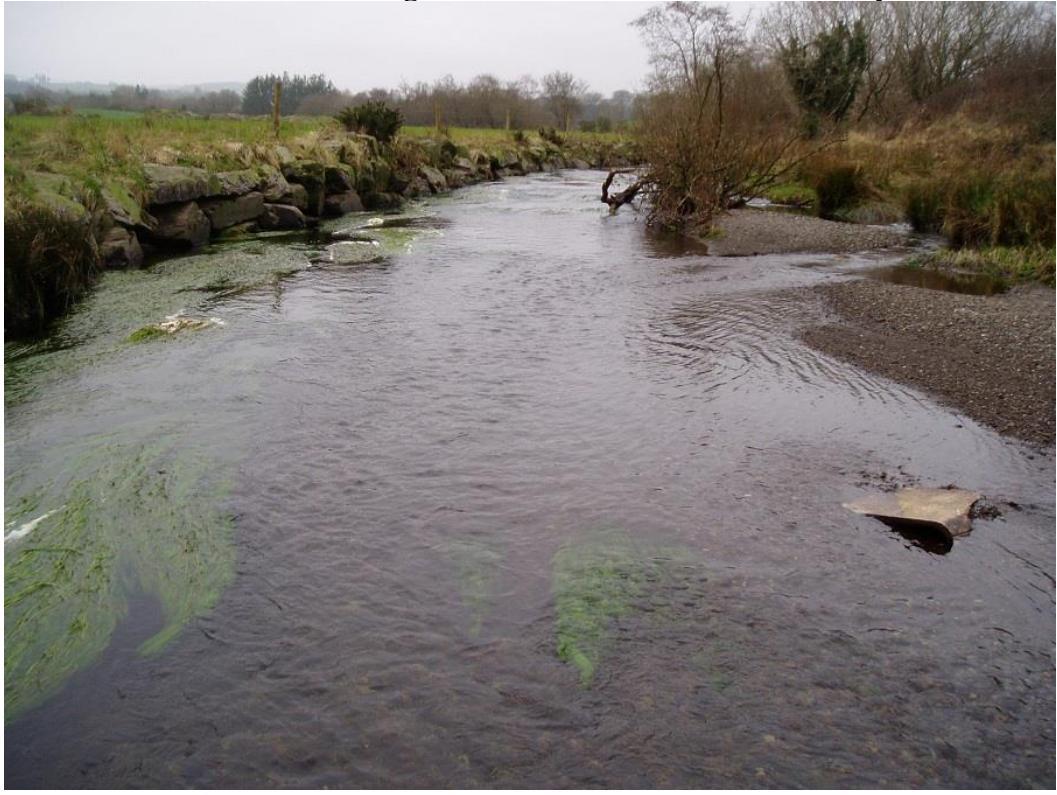
Photo 38: Bridge apron at Keenrath Bridge Sampling Site M1
